Klozur® One Application Destroys over 99% of Trichloroethylene in Five Weeks at a Former Manufacturing Facility in The Netherlands

Site Type: Former Manufacturing Facility

Location: Uden City Center, The Netherlands

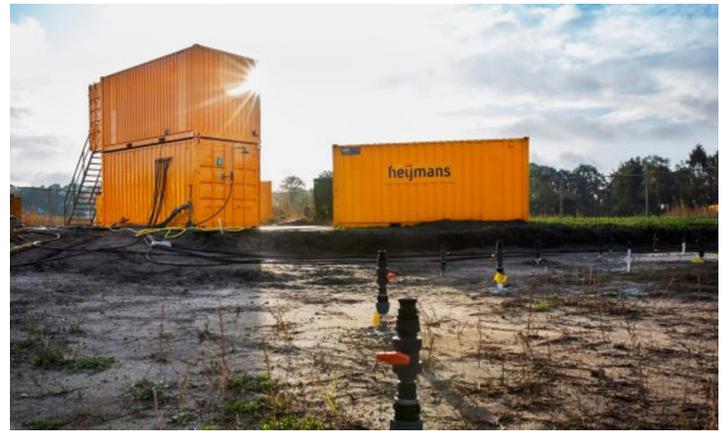
Figure 2. Injection Well Manifold

With this grid, it was possible to engineer contact across the entire source area. At spots with higher concentrations of contaminant, more solution was applied with a higher concentration of persulfate. At each injection point between 2,775 and 4,500 liters of solution were applied. Through use of a manifold system (Figure 2), 4 to 6 wells were worked simultaneously, using a little overpressure to prevent blow-out at the surface. In total, the field work lasted nine days injecting 155 m³ of Klozur One injection fluid.
